# Inspection Report

123 Main St.  
Anywhere, NE 55555

**Superior Home Inspections LLC**

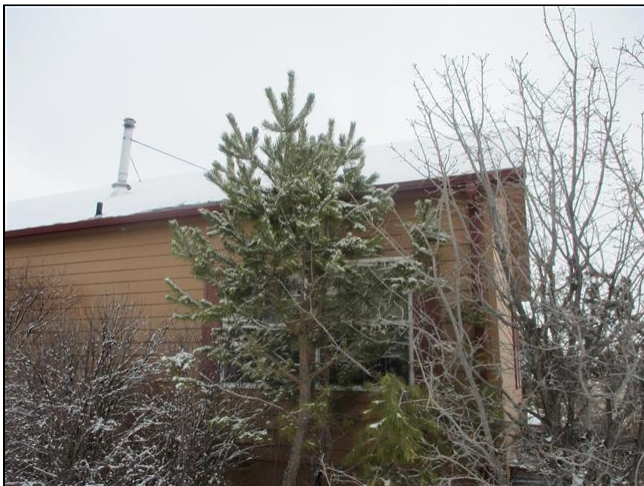
1.2 Item 3(Picture)

**1.2** The tree limbs that are in contact with roof or hanging near roof should be trimmed.

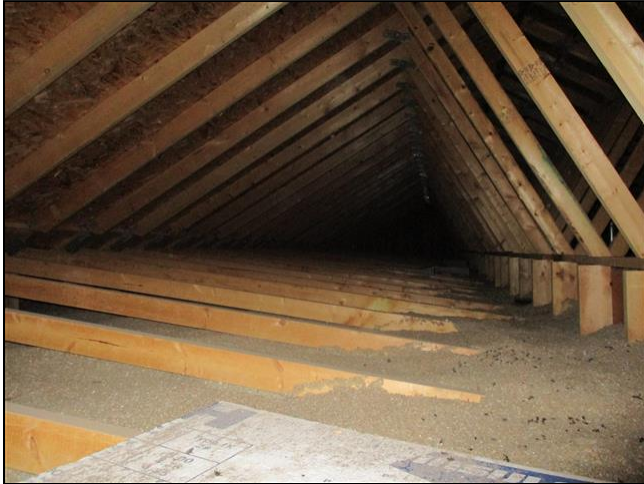
1.4 Item 1(Picture)

1.4 I did NOT walk the roof due to being covered in snow. The roof looked to not have any defects from the attic looking up.

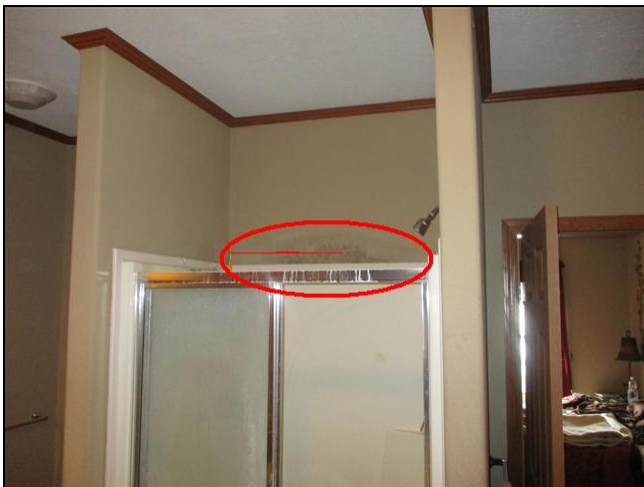
1.8 Item 1(Picture)

1.8 (1) Signs of fungi growth is present above the shower insert in south west bedroom bathroom. We did not inspect, test or determine if this growth is or is not a health hazard. The underlying cause is moisture. I recommend you contact a mold inspector or expert for investigation or correction if needed.

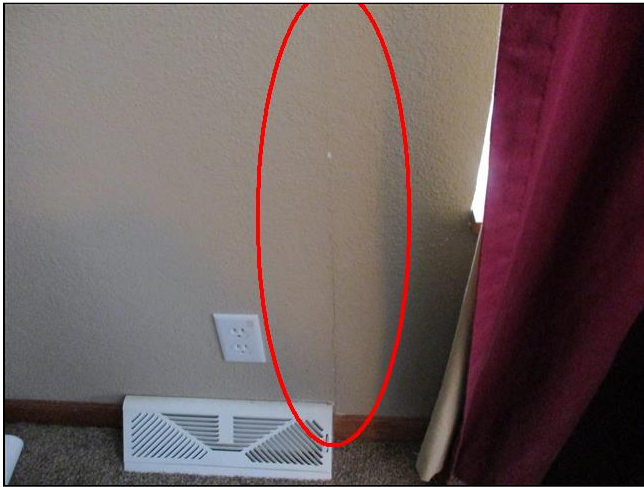
1.8 Item 4(Picture)

(2) The sheetrock is cracked at the south west bedroom. This damage is considered cosmetic.

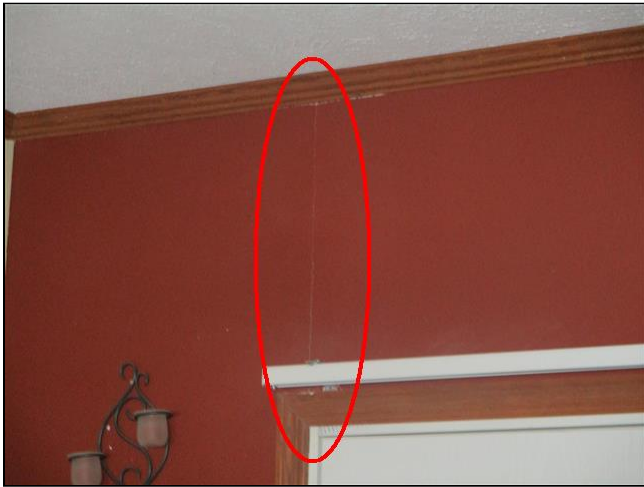
1.8 Item 7(Picture)

(3) The sheetrock is cracked in the Dining Room above patio doors on left and right side.

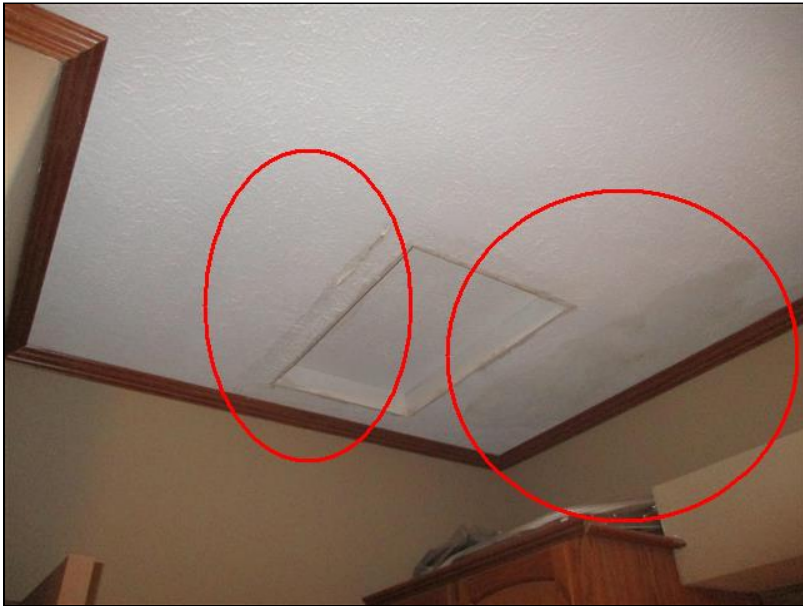
1.9 Item 1(Picture)

**1.9** (1) The Texture on the ceiling is peeling or loose and stained in the south west bedrooms bathroom. The moisture meter was used and it recorded 19% or higher, which indicates the leak has not been corrected. A qualified person should repair or replace as needed.

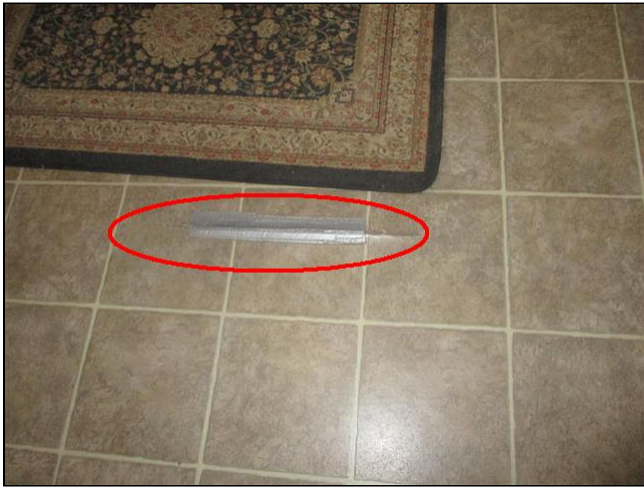
1.9 Item 7(Picture)

(2) The Vinyl and Sub floor are cracked and damaged in the Kitchen. Repairs are needed. A qualified person should repair or replace as needed. There is a piece of paper stuck in crack from upstairs in the kitchen and it is showing in the basement through the floor.

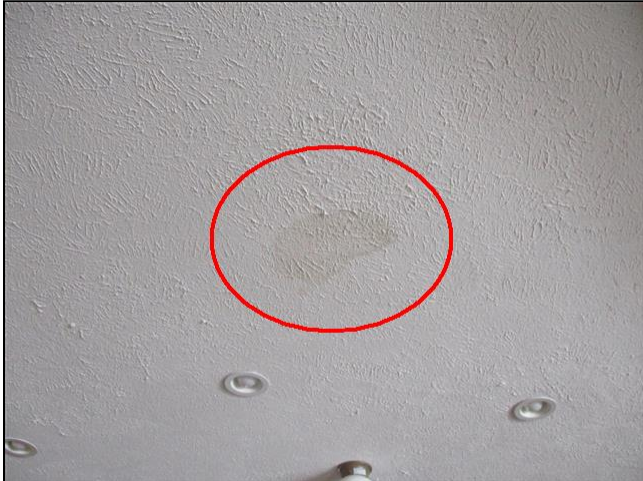
1.9 Item 11(Picture)

(3) The ceiling has a stain indicating a leak did or still exists at the Kitchen. I am unable to determine if a repair is needed due to a lack of rain. I recommend monitor and repair leak if detected.

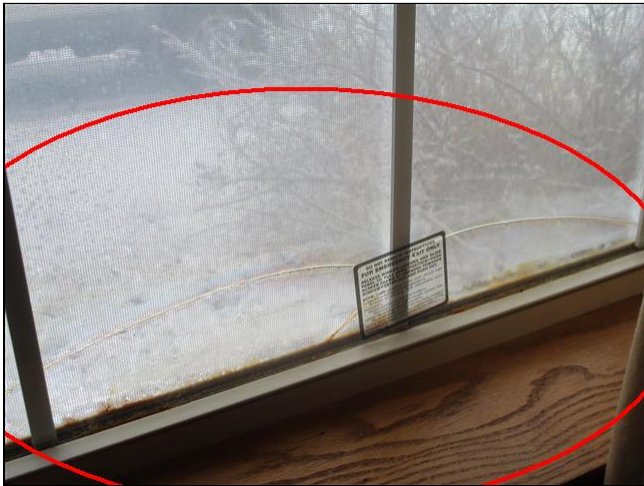
1.11 Item 1(Picture)

**1.11** (1) There was cracked glass in south west bedroom.

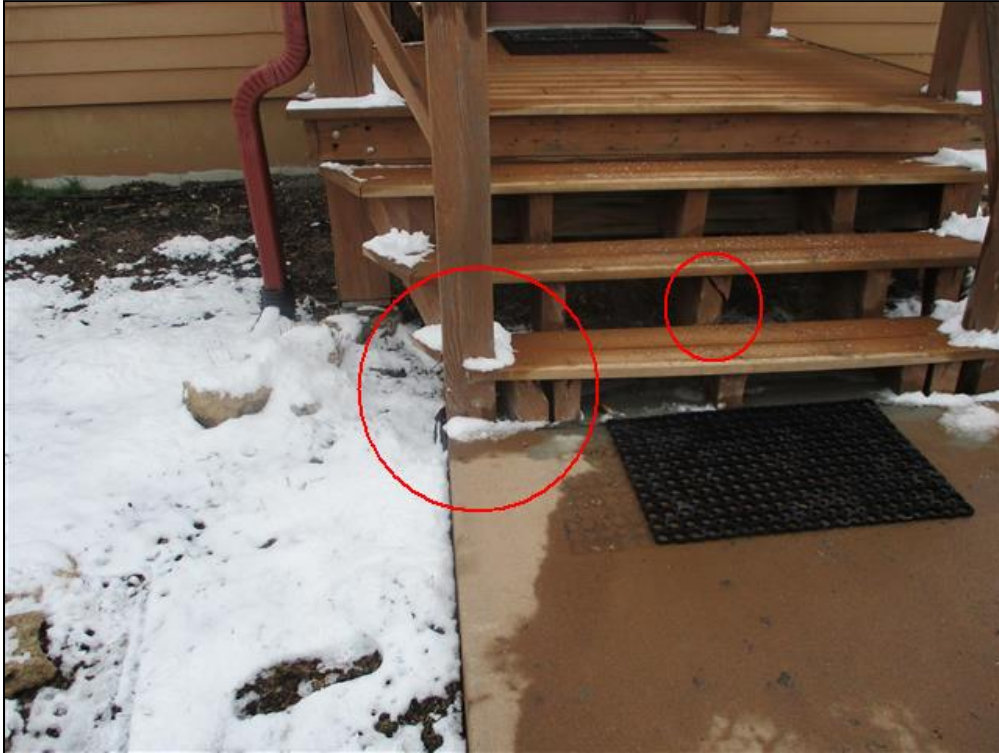
1.12 Item 1(Picture)

**1.12** (1) Support post under stairs and stair stringers to the steps to the front porch deteriorated, and needs replacement. Further deterioration can occur if not repaired. .

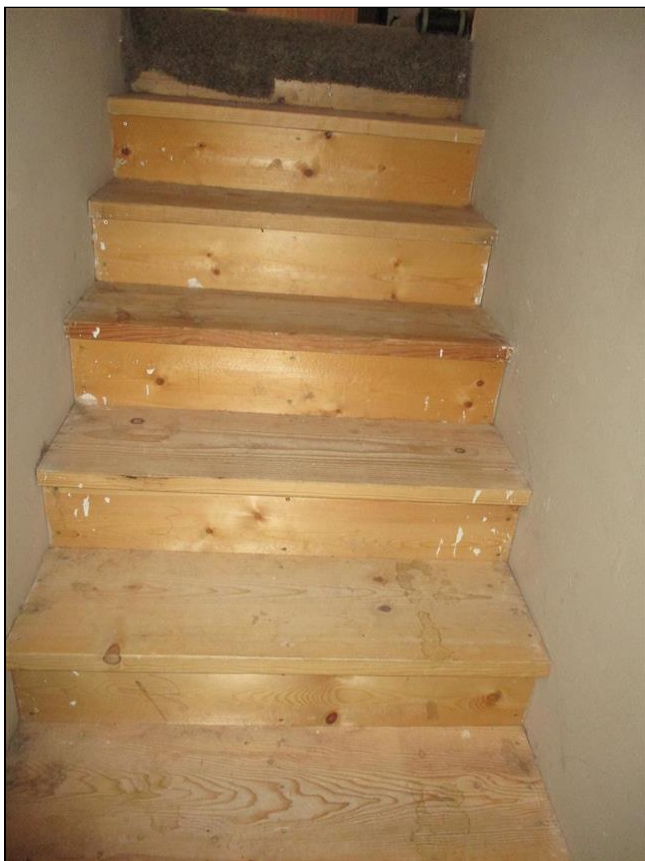
1.12 Item 4(Picture)

(2) There was no covering on stairs leading to the basement.

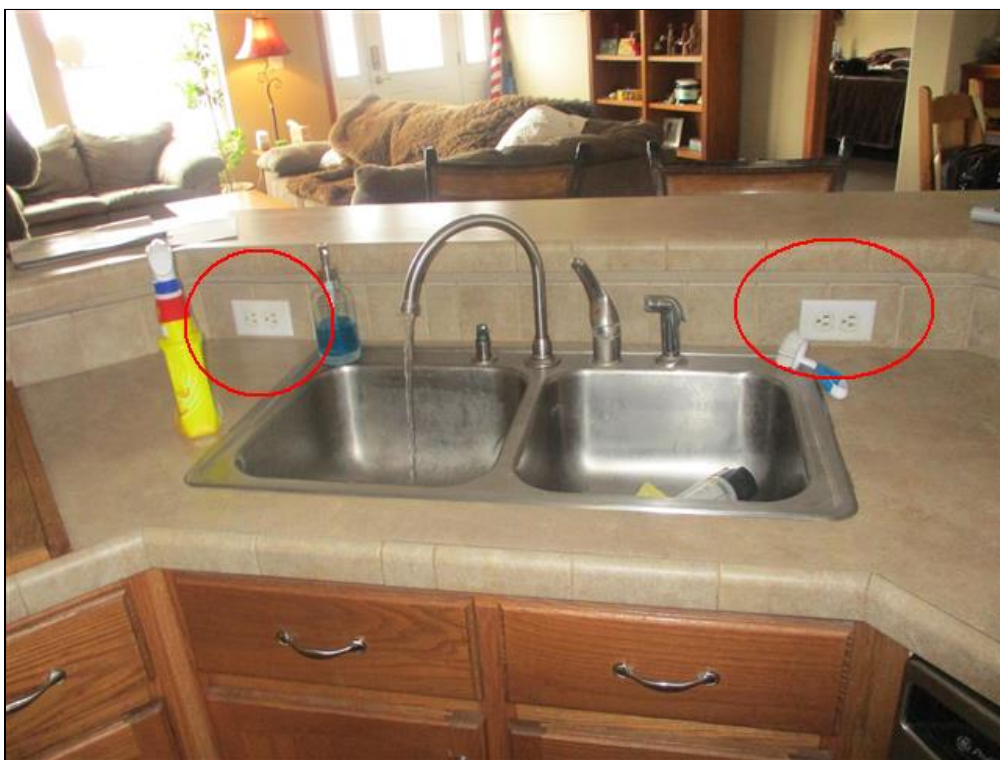
2.4 Item 1(Picture)

**2.4** (1) GFCI (Ground Fault Circuit Interrupter) outlets are needed at the Kitchen . This is a safety issue that needs to be corrected. A qualified licensed electrical contractor should perform repairs that involve wiring.

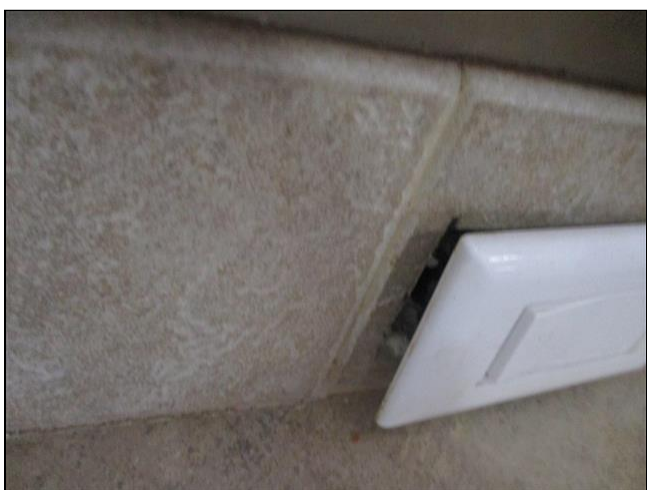
2.4 Item 5(Picture)

(2) GFCI (Ground Fault Circuit Interrupter) outlet is needed at the kitchen by the sink, and needs to be secured properly. This is a safety issue that needs to be corrected. A qualified licensed electrical contractor should perform repairs that involve wiring.

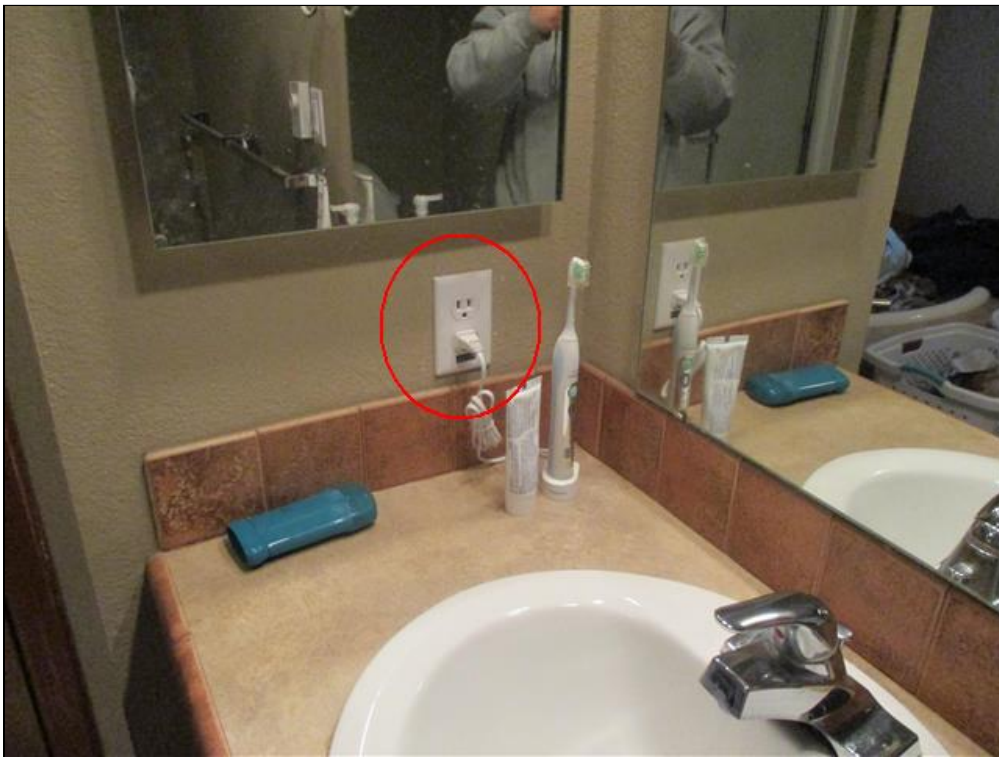
2.4 Item 9(Picture)

(3) Outlets in bathroom were labeled GFCI but no reference point to reset.

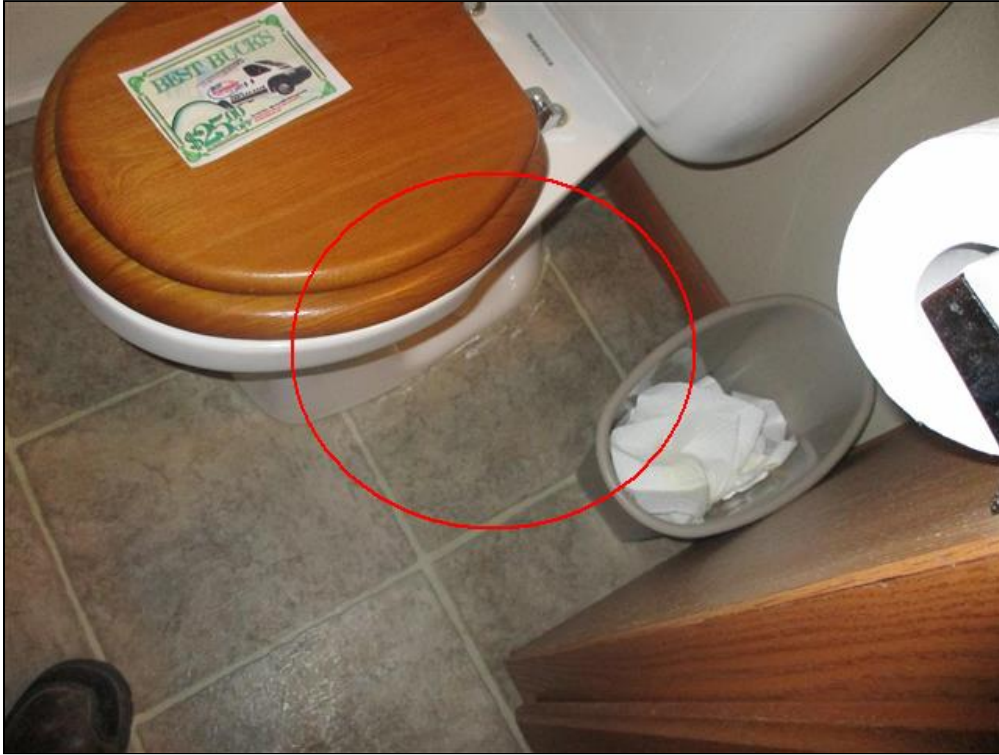
4.0 Item 1(Picture)

4.0 The toilet is loose at floor at the bath. Repairs may involve re-setting the toilet on a new wax seal. I recommend a qualified licensed plumber repair or correct as needed.

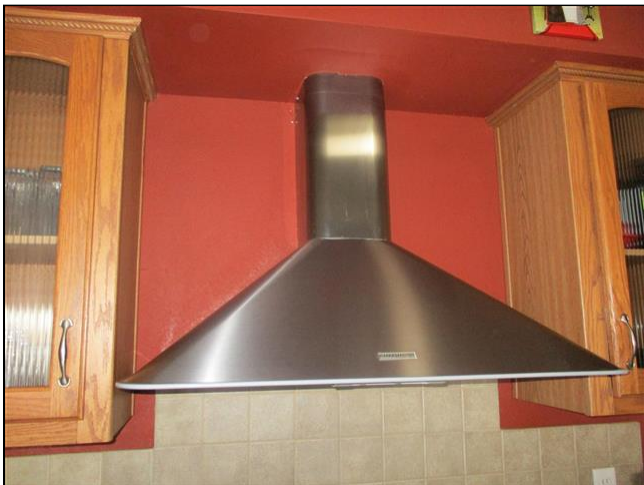
5.2 Item 1(Picture)

5.2 The range hood fan works but old and no longer effective has crust or grime build-up. I recommend repair or replace as needed.

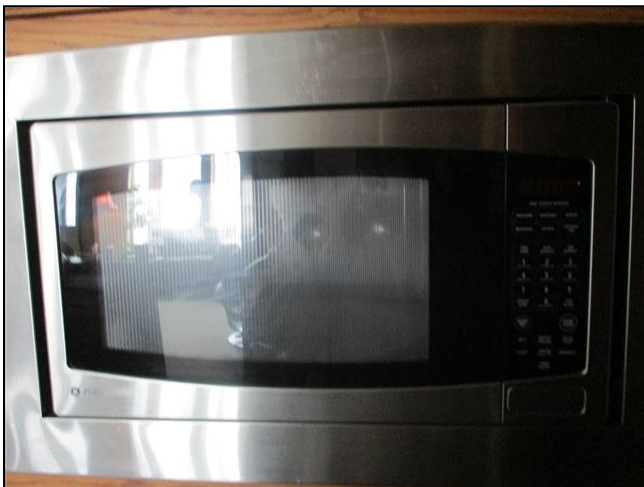
5.5 Item 1(Picture)

5.5 The microwave door handle is broken. I recommend repair as needed.
